OP5 APPENDIX 9.25 - CONSERVATION MANAGEMENT PLAN

December 2021 Otterpool Park LLP

## WESTENHANGER CASTLE: FRAMEWORK CONSERVATION MANAGEMENT PLAN

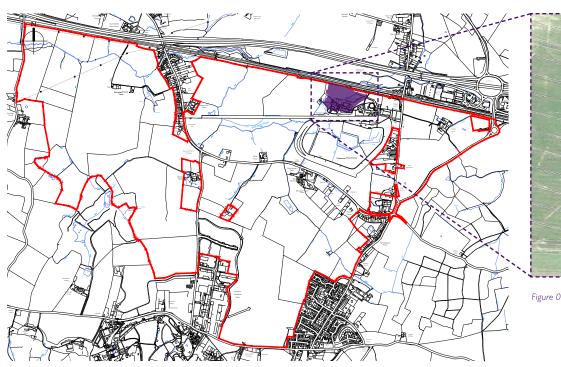
Figure 01: Red line boundary for the Outline Planning Application of Otterpool Park Garden Settlement. The area highlighted purple shows the scheduled area that forms the focus of the CMP.

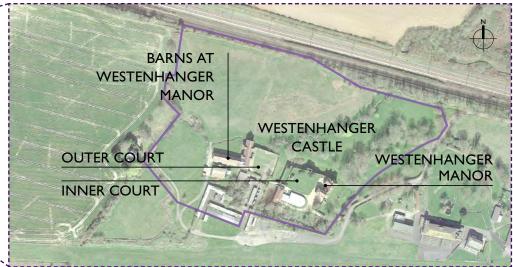
Figure 02: Detail of the scheduled area, outlined in purple, that forms the focus of the CMP

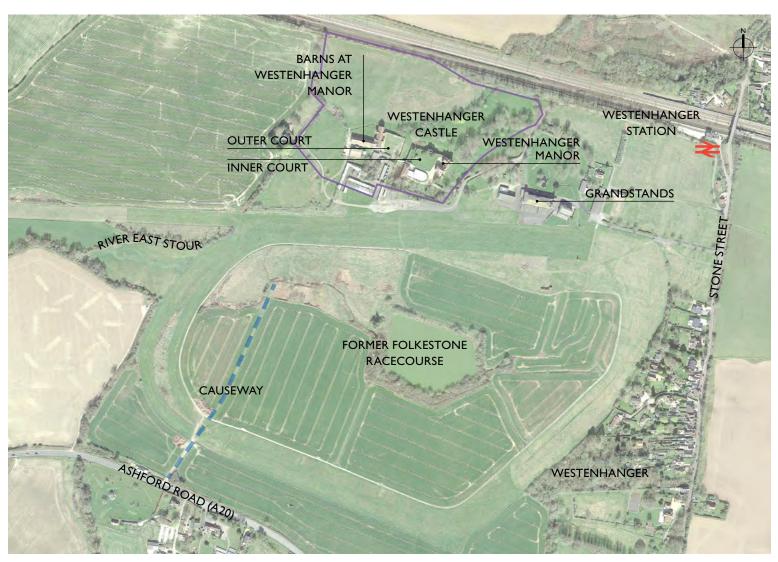
Figure 03: The location plan shows the site of the Scheduled Monument at Westenhanger, outlined in purple, and labels the key buildings on the site, as well as local landmarks. (Base plan © GoogleEarth 2021)

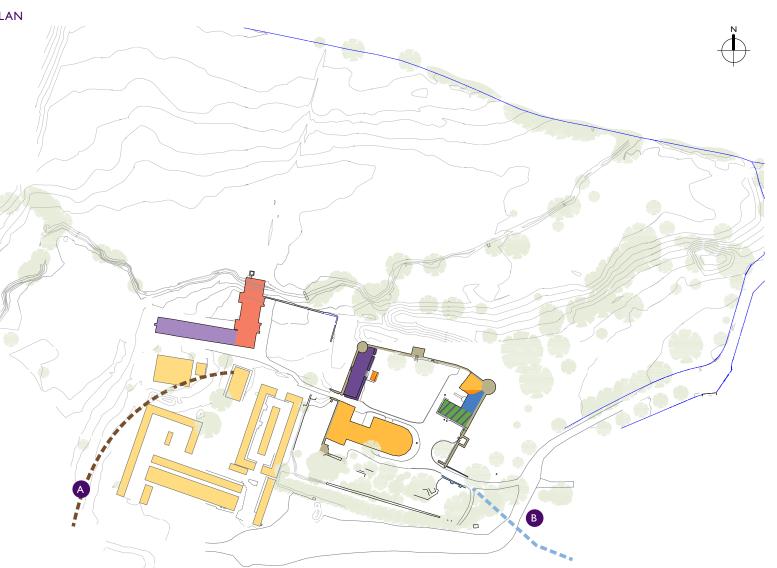
- 14th Century
- Early 16th Century
- Late 16th Century
- 18th Century
- 19th Century
- 20th and 21st Century
- A Approximate location of historic causeway approach to the south-west of the site, likely of medieval origin
- B Approximate location of former Pound House Track, in place by the mid/ 19th century

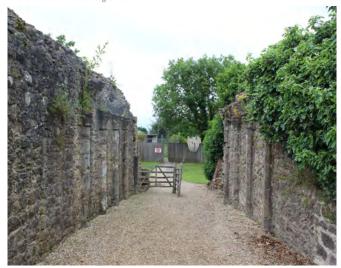
Figure 07: View looking west through the gatehouse entrance towards the barns showing the surviving pillars, formerly part of a vaulted entrance

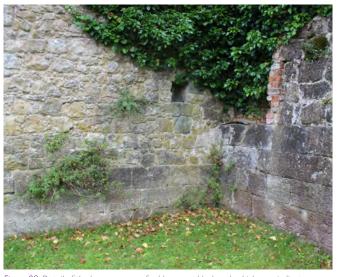
Figure 08: Detail of the lower courses of ashlar or cut blockwork which may indicate an earlier phase in the castle's construction

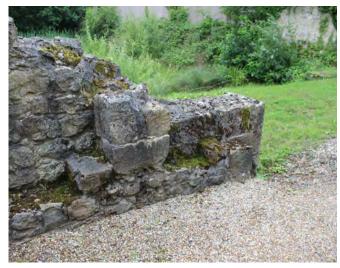
Figure 09: Pivot hole for the former drawbridge in the gatehouse entrance

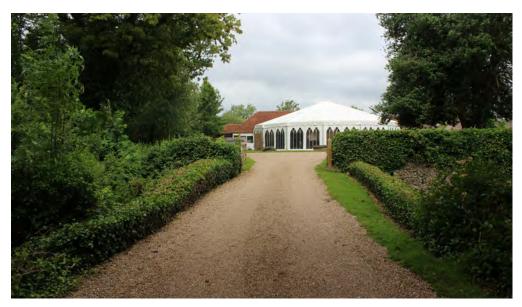
The east entrance is via an ivy-clad stone bridge crossing the east arm of the moat. This entrance is a later addition to the historic west entrance.

Figure 10: View looking west over the bridge crossing the east arm of the moat and forming the east entrance to the castle complex

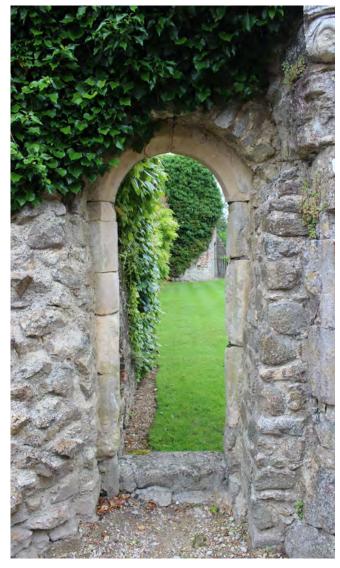
Figure 16: Round-arched entrance from the gatehouse to the adjacent west range

arched, chamfered doorway accesses this range from the gatehouse. Surviving Tudor elements include a red brick herringbone fireplace, a Tudor doorway and a wide-splayed window adjacent.

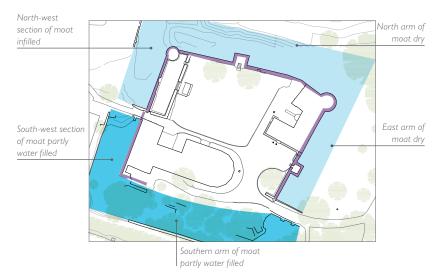
The north end of the east curtain wall is incorporated into the Manor House and survives well, although to the south the remains are lower and terminate at the bridge entrance with the southern stretch no longer extant. The stub of curtain wall to the south of the main range of the house features a window jamb at first floor level, indicating the presence of former accommodation here. This section of wall and the lower remains to the south are overgrown with ivy.

Figure 17: View of the east curtain wall looking northwest showing the north section and the north-east tower incorporated into the Manor House and the lower remains to the south. The east arm of the moat is dry.

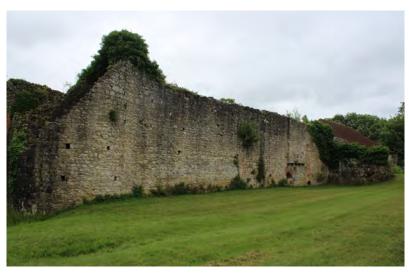
Figure 22: View of the north end of the west curtain wall looking south showing the north-west tower in the left foreground, the gatehouse in the right background and the infilled moat in front

The west curtain wall is continuous except for a break at the central gatehouse. The walls are lower than the north curtain wall and the north section of the east curtain wall, particularly the southern end adjacent to the modern services building.

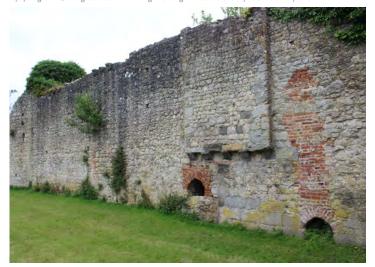
Figure 23: View of the north end of the west curtain wall looking north showing the north-west tower in the background and the infilled moat in front

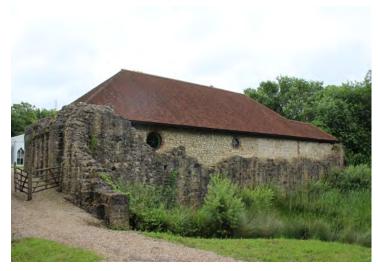
Figure 24: View of the south end of the west curtain wall showing the adjoining services building and the south-west section of the moat that remains partially filled

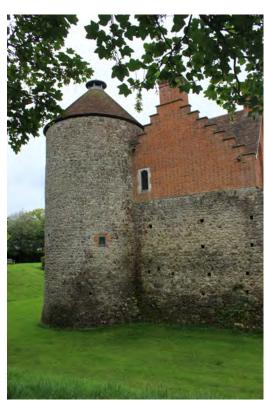
Figure 25: View of the north-east tower looking south

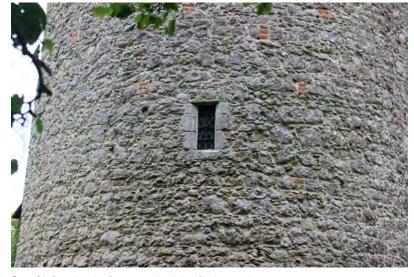
Figure 26: Central window featuring medieval chamfered surround

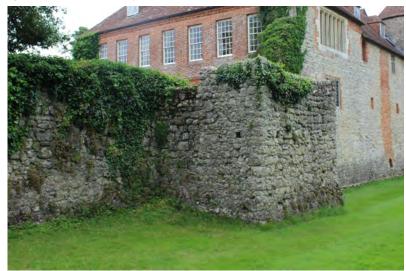
The south-east tower, which adopts a square plan, projects diagonally into the moat and is constructed of roughly – hewn stone. Only the base survives, which features minimal architectural or decorative features aside from the put-log holes used during construction.

Figure 27: View of the south-east tower looking north-east

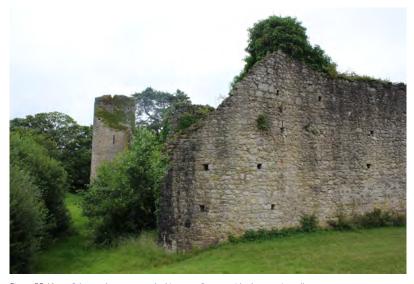
Figure 29: View of the north-west tower looking east from outside the curtain wall

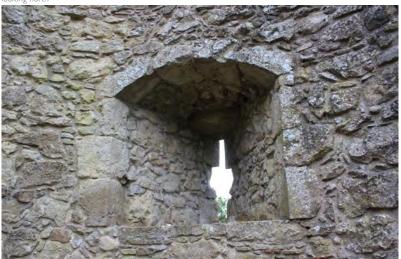
Figure 30: View of an arrow slit window in the north-west tower

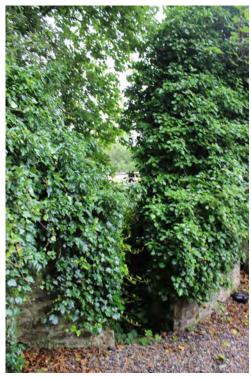
Figure 32: View of the south-west tower looking south-west

The south-west tower adopts a smaller plan than the other towers and is the most incomplete. The circular tower is hidden away behind the modern services building, associated extensions and plant, and the marquee, all of which block views towards the tower. The remains of the tower are further concealed by ivy and other foliage. The walls are of roughly hewn stone and there do not appear to be any arrow slits.

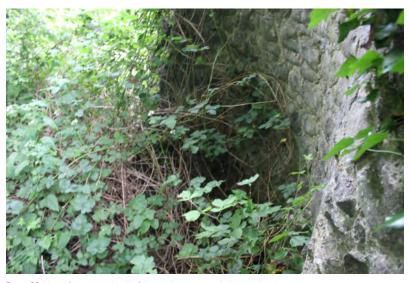
Figure 33: View of the internal wall of the south-west tower looking norh-west

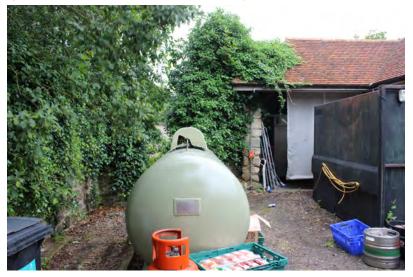
Figure 34: View looking towards the south-west tower, which is obstructed by modern plant relating to the services building

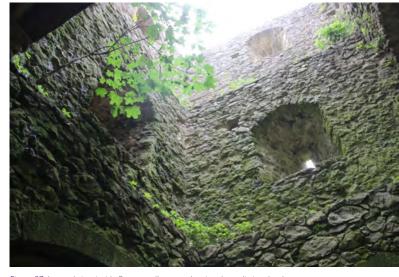
Figure 37: Internal view inside Rosamund's tower showing three distinct levels

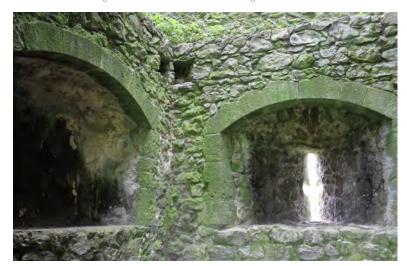
Figure 38: Internal view inside Rosamund's tower showing a slit window and a fireplace, both with dressed masonry surrounds

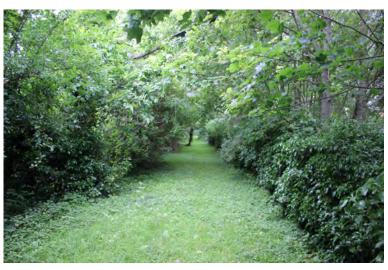
Figure 39: View looking west along the south terrace showing the dense vegetation screening the feature from view

The terrace lining the south side of the moat, and separated from it by a retaining wall, forms part of a late 16th century phase of formal landscaping as a private garden for the no longer extant south range. The lawn terrace is framed by trees and shrubbery on either side: the tree planting to the south of the moat and the overgrown vegetation within the moat.

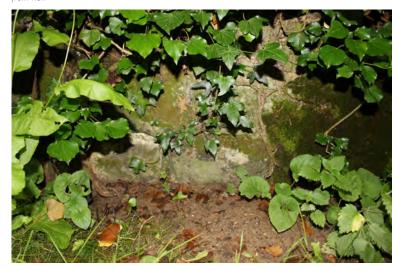
Figure 40: Detail of the masonry retaining wall separating the terrace from the moat
