Road Safety Assessment Princes Parade, Hythe

Document reference: INVVU/273755/RSA/001

Proposed Parking Layout Options

Road Safety Assessment

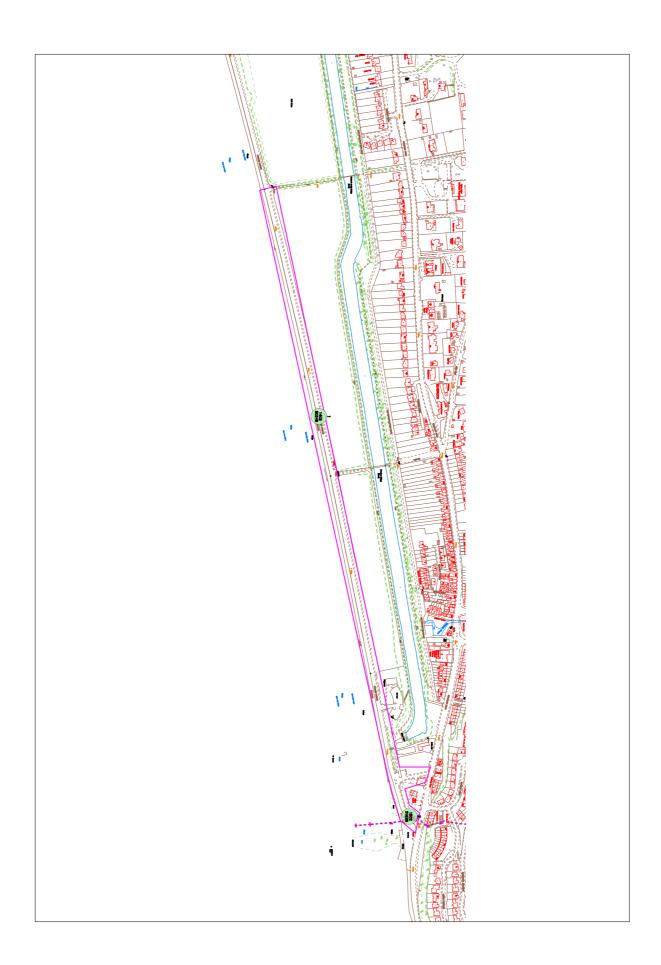
Title: Princes Parade - 3 year crashes (1)

There were 2 reported crashes resulting in injury

No	Location	Severity	Date	Day	Time	Street Lighting	Road Surface	Weather	Pedestrian Direction	Factors		Involv	ved
1	Road No F1423 Grid 618233 Section 142 Ref 134723		01/12/2014	2	17:46	DRK NSL	Dry	Fine					
	Princes Parade, by Hythe Bus	Shelter, Folkesto	one, Kent						Shepway				
	V1 was Travelling Towards Hythe, as Passing Parked Vehicles on It's Near-Side, Oncoming Vehicle Dazzled Driver. V1 Moved Clipping Wing Mirror of V2 and Hitting Front Off-Side of V3.							Veh1, car, NE -> SW Veh2, car, NE -> SW Veh3, car, NE -> SW			Casua Vehic		1 3
2	Road No A259 Grid 618978 Section 231 Ref 134898		04/01/2015	1	10:40	L	Dry	Fine		R.TURN			M/C
	Princes Parade 10 Metres Sou	n of A259 Seab	rook Road, Hy	the, k	Cent				Shepway				
	V2 Has Pulled into Princes Parade from the A259 from the Folkestone Direction. V1 Has Entered Princes Parade Also but from the Hythe Direction. V2 Has Indicated to Enter the Garage and Started to Perform the Manoeuvre to Enter, V1 Has Not Seen the Indicator and Hit the Back of V2.						Veh1, m/cycle <= 50cc, NE -> SW Veh2, car, NE -> SW			Casua Vehic		2 2

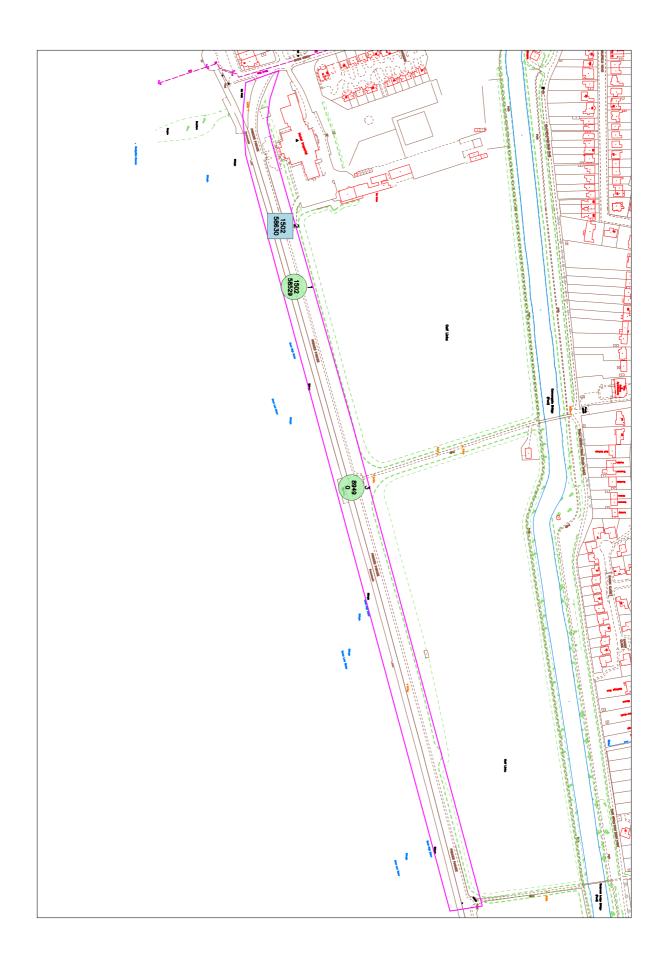
Title: Princes Parade - 3 year crashes (2)

There were 3 reported crashes resulting in injury

No	Location	Severity	Date	Day	Time	Street Lighting	Road Surface	Weather	Pedestrian Direction	Factors		Involv	ved
1	Road No F1423 Grid 61709 Section 142 Ref 13445	-	04/07/2015	7	18:35	L	Dry	Fine					M/C
	Princes Parade, Hythe, Kent	Mapped to 61709	0 / 134400)						Shepway				
	V1 was Parked by the Roadside, Driver of the Car Performed a U-Turn, as They Began to Reverse Back They Saw a Moped Sliding Towards Their Car, the Moped then Struck the Passenger Side of the Car.						Veh1, car, SW -> NE Veh2, m/cycle <= 50cc, SW -> NE			Casua Vehicl		1 2	
2	Road No F1423 Grid 61702 Section 142 Ref 1344	· =	04/07/2015	7	00:38	DRK NSL	Dry	Fine					
	Princess Parade, Hythe, Kent	(Mapped to 6170	20 / 134410)			•			Shepway				
	V1 Has Made Contact with V2 Substational Rear Damage	. V1 Has Substat	ional Front Da	mage	. V2 Has	S	Veh1, car, W -> E Veh2, car, W -> E				Casua Vehicl		3 2
3	Road No U Grid 61733 Section Ref 13445	5E 7N SLIGHT	23/07/2016	7	19:18	L	Dry	Fine		R.TURN			M/C

PRINCES PARADE AT LAYBY NEXT TO CANNONGATE BRIDGE FOOTPATH (MAPPED TO Shepway DESCRIPTION)												
	V 2 was stationary indicating to turn right off Princes Parade into a Parking area. As V2 did so V1 collided with V2 on its offside. Causing minor damage. V1 rider suffered minor injuries and taken to WHH.							Veh1, m/cycle 125 - 500cc, E -> W Veh2, car, E -> W			Casua Vehicl		1 2
